## CSU Extension. Innovation Award Proposal Final Report. June 2010

### Mesa County / Tri-River area Small Acreage Irrigation Audit program

### Small Acreage Irrigation Assessment Report

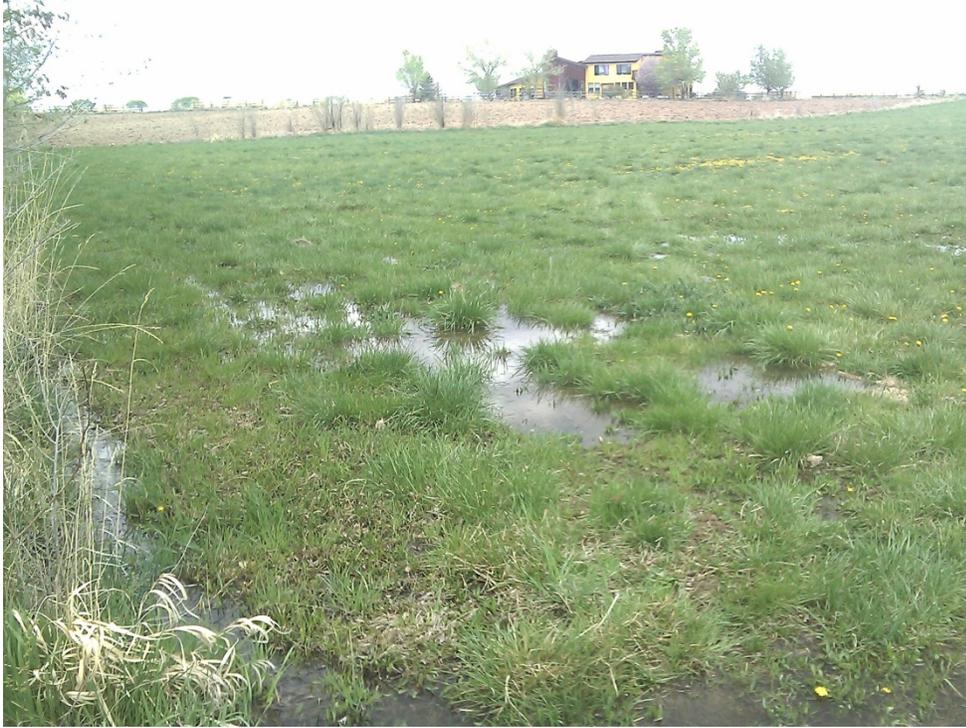
1. The irrigator had severe ponding at bottom of the field which is a symptom of excessive irrigation volume (see photo 1). This field and crop would receive sufficient water with a 12 hour set every 10 days (14 days in spring and fall). Any more than 24 hours of irrigation will hurt the quality of the crop, create a mosquito breeding environment, and promote weed growth.

Photo 1: Ponding at bottom of field, a symptom of excess irrigation water.

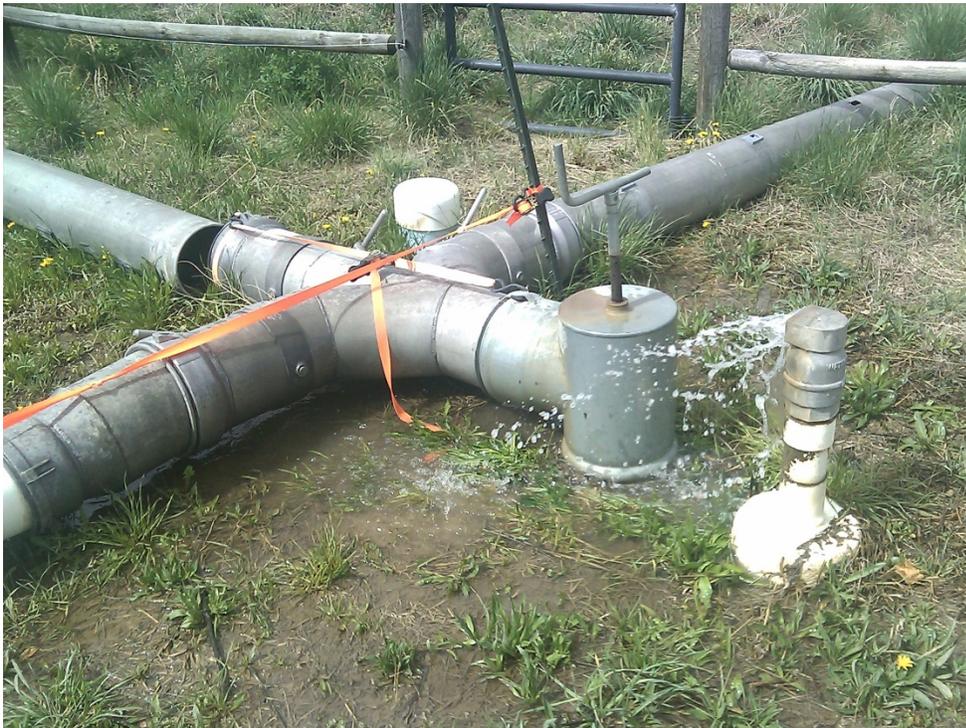
2. Distribution Uniformity (DU<sup>2</sup>) was 48.3% (poor) due to leaking gates and creases that were either not recently marked or cleaned after marking. Seasonal Efficiency (SE<sup>3</sup>) was 4.6% (very poor) which means most of the water entering the field is ponding or running off. Leaking gates can be addressed by lowering feed pressure at Stubb Valve (see photo 2). This will also eliminate the need for straps to hold pipe together.

Photo 2: Stubb Valve with strapped leaking pipe and vent valve (vent valve is on the right spraying water at larger Stubb Valve). Choking back Stubb Valve will eliminate a lot of leaks and need for straps.

3. Clean vent valve. This valve is probably collecting trash due to high pressure, push ball release down to vent and clean (see photo 2).
4. Irrigation and Pond water quality parameters were all within acceptable limits (see attached lab reports).
